11 MAY, 1988

BULLETIN.003

SYNCHRO-PULSE CDT 350: CP34 CP34-29 FUNCTION PCB

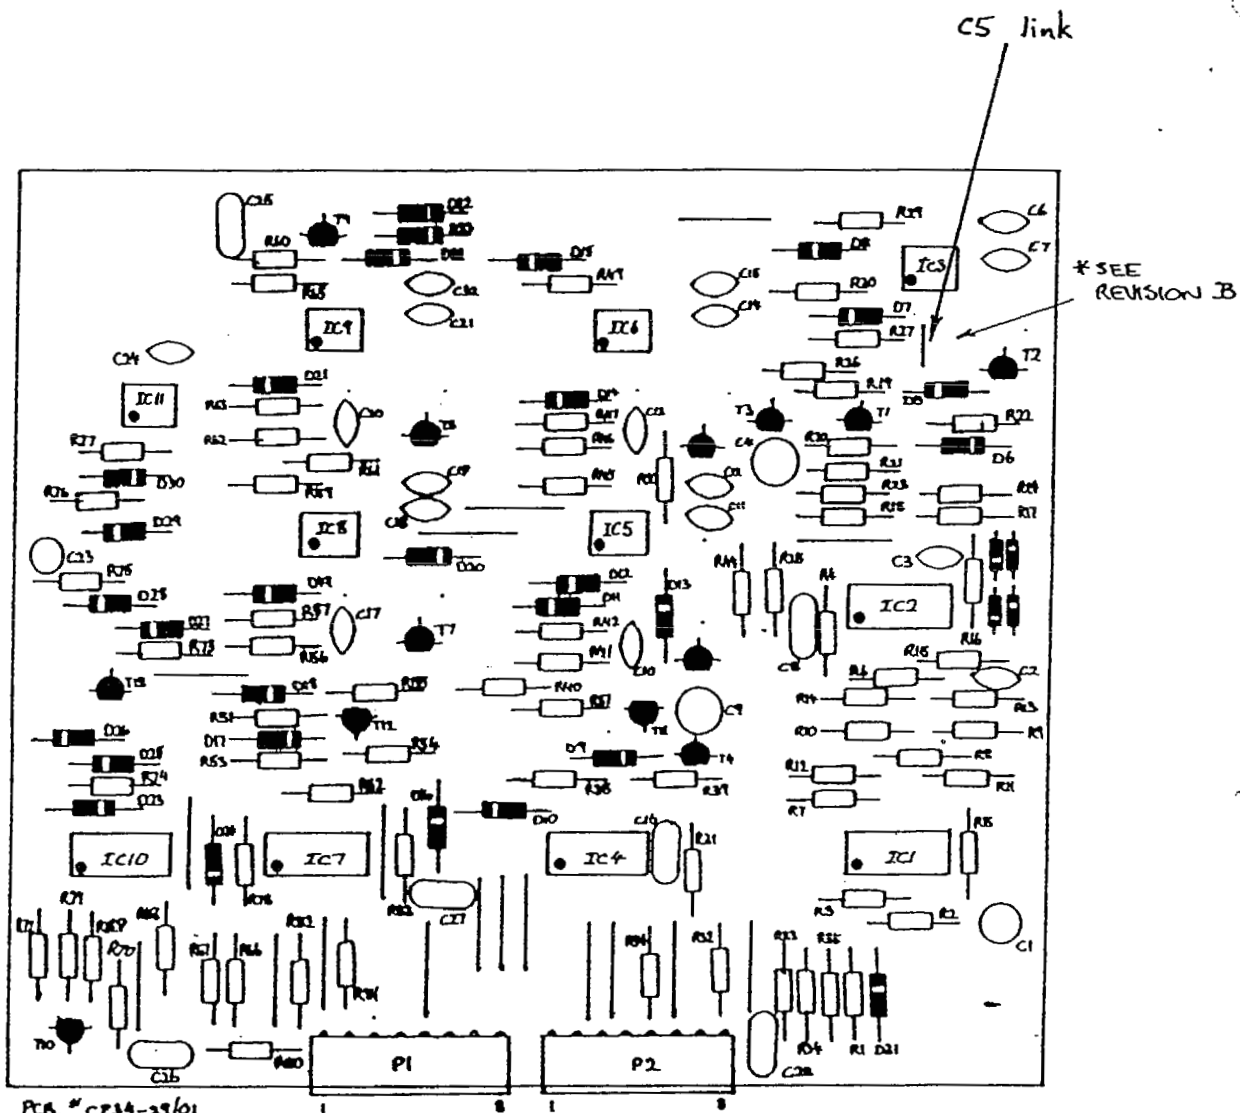
TITLE
CP34-29/01 COMPONENT OVERLAY.
FUNCTION BOARD.

This is to overcome a latch-up fault, which is when there is insufficient power to melt the welding wire properly, causing the wire to coil up onto the workpiece like "cold spaghetti".

Capacitor C5 (Greencap) is to be removed and replaced by a link.

Refer to attached component overlay for position of C5.
