BULLETIN.113

## CP38 DISPLAY RESETTING FAULT

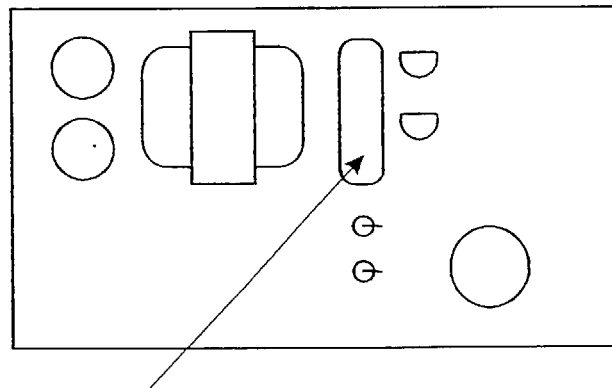
There have been several instances recently reported of CP38 CDT 450's frequently resetting back to 0.6 Carbon Steel Schedule. In many cases this has resulted from fracture (probably due to vibration fatigue) of at least one lead of a capacitor which is part of the inverter assembly which drives the LCD screen backlight. The capacitor is shown in the diagram below.

Check this capacitor

Field repair is possible, but requires the careful desoldering of the inverter module from the CP38-11 pcb in order to gain access to the capacitor terminations. Following repair, the capacitor should be supported by the application of hot-melt glue or silicon sealant between the capacitor and adjacent components.
