15 NOVEMBER, 1994

BULLETIN.118

HT24-11, HT24-12 HULFTEGGER NECKS

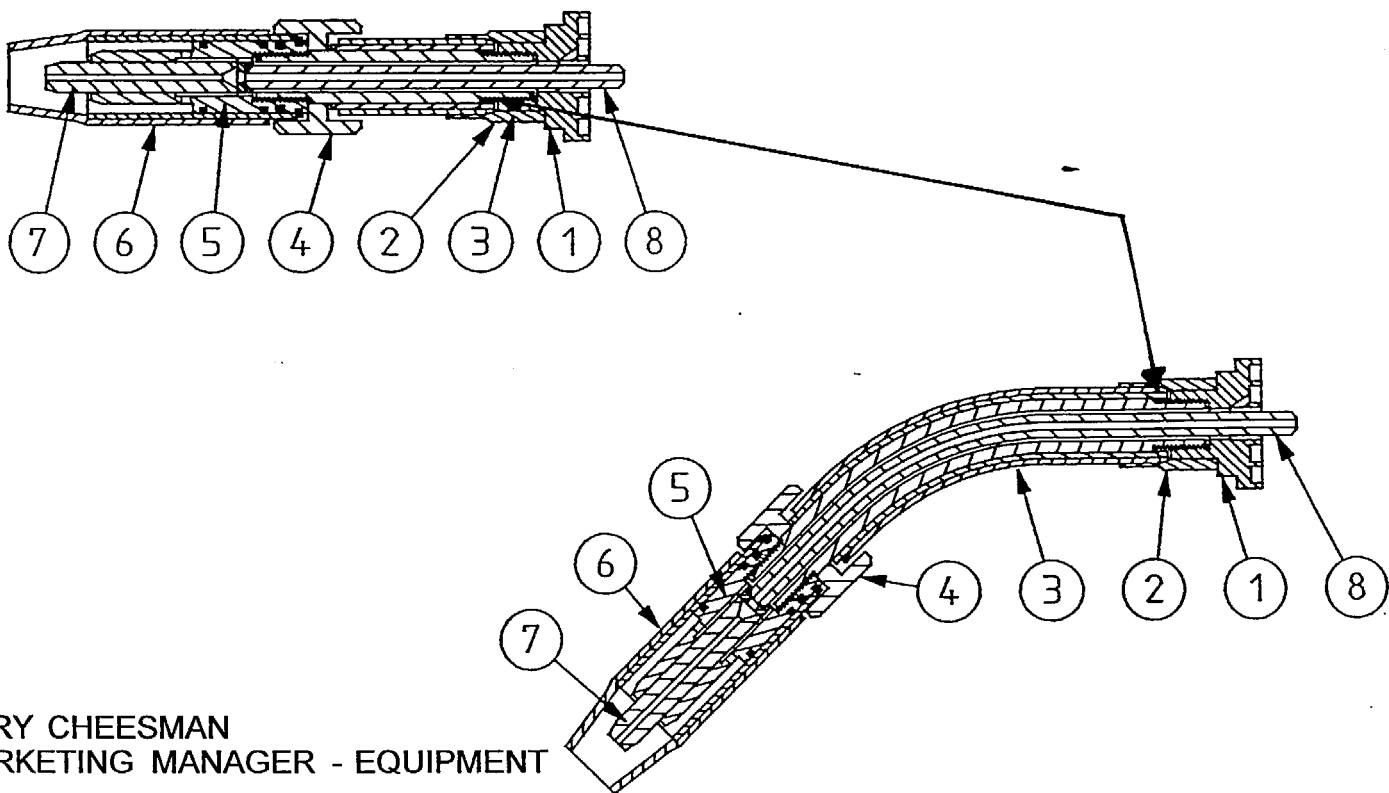
There have been several field reports concerning the above assemblies. The particular problem is that the screwed joint between the neck adaptor, HT24-11/1 and the Bernard stem has been sealed at assembly with Loktite, which causes poor electrical contact between the two items.

The result is that welding current tends to flow to the welding wire at the drive rollers rather than the welding tip, hence the welding characteristics are poor, and the heated welding wire melts the nylon guide.

If this problem is encountered, carefully unscrew the affected joint, and remove all traces of the Loktite. Re-assemble tightly with no sealant.
