9 OCTOBER, 1995

BULLETIN.131

CP38-13 BACKGROUND DRIVER BOARD

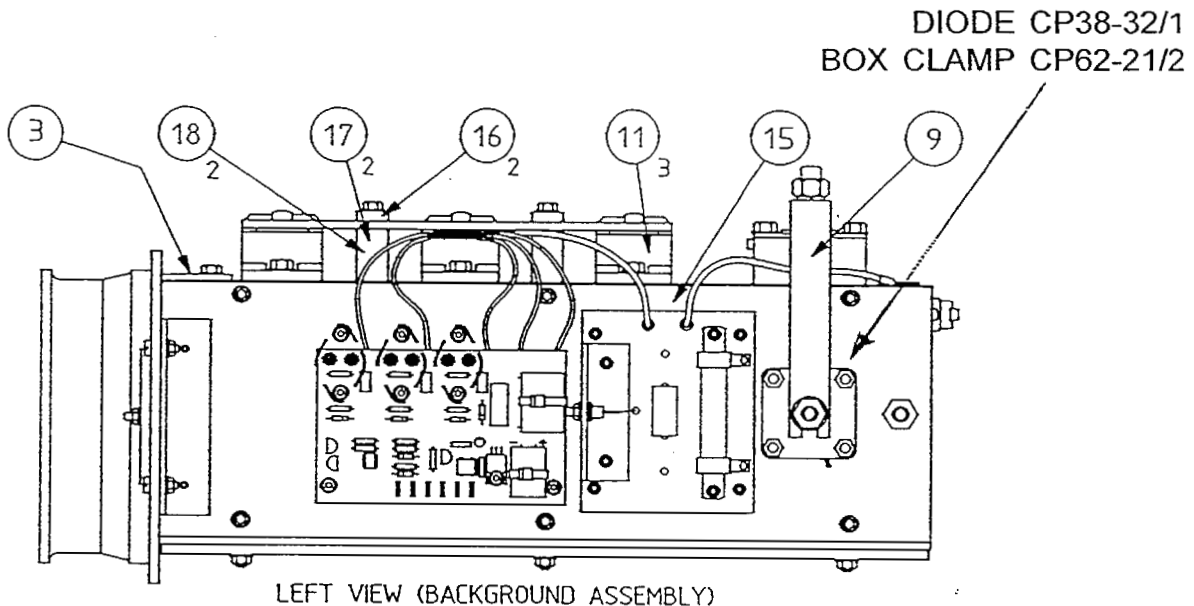
Investigation showed that the fault occurred as a result of a loose background fly wheel diode. This component is mounted in a box clamp, and the clamp in question was missing one of the two Belleville washers which apply the intended clamping pressure. With intermittent or high resistance at this point in the circuit, excessive voltage was applied to the transzorbis leading to their eventual overheating and failure. It is possible that the fault may be present in other CP38's in the field.
