BULLETIN #168

## MILLER GOLD SEAL 160i

### OUTPUT CURRENT DECREASES

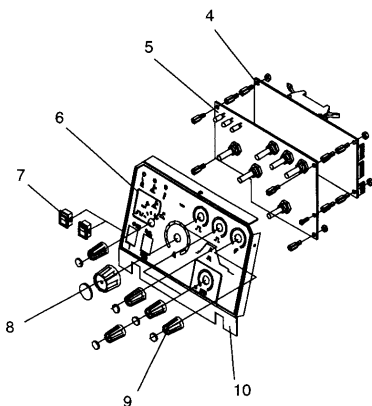
Fig 1

This can be caused by the Local/Remote Selector Switch on the control panel (located in the lower left corner) being set to "Remote Control" when there is no remote control connected. This switch should be set to the "0" position (pushed in at the top) when a remote control for output current is not connected. It may be necessary to turn the machine off/on after changing the position of this switch. There have been a small number of cases where a poor connection to this Local/Remote Switch has caused a similar problem. The problem has been identified as a poor connection in the loom which links the Local/Remote Switch to the Logic PCB. Miller Europe have provided replacement looms which can be fitted to prevent this problem.

1. Remove the cover.
2. Remove the 4 nuts to detach the Logic PCB (item 4, Fig 1). Note the washers on both sides of this PCB at one corner only.
3. Remove the old loom and fit the new one, maintaining the same connections.
4. Refit all components and test.
