BULLETIN # 196

SYNCHROPULSE CDT450, CP38 WITH W37

WIRE DRIVE SPEED IRREGULARITY

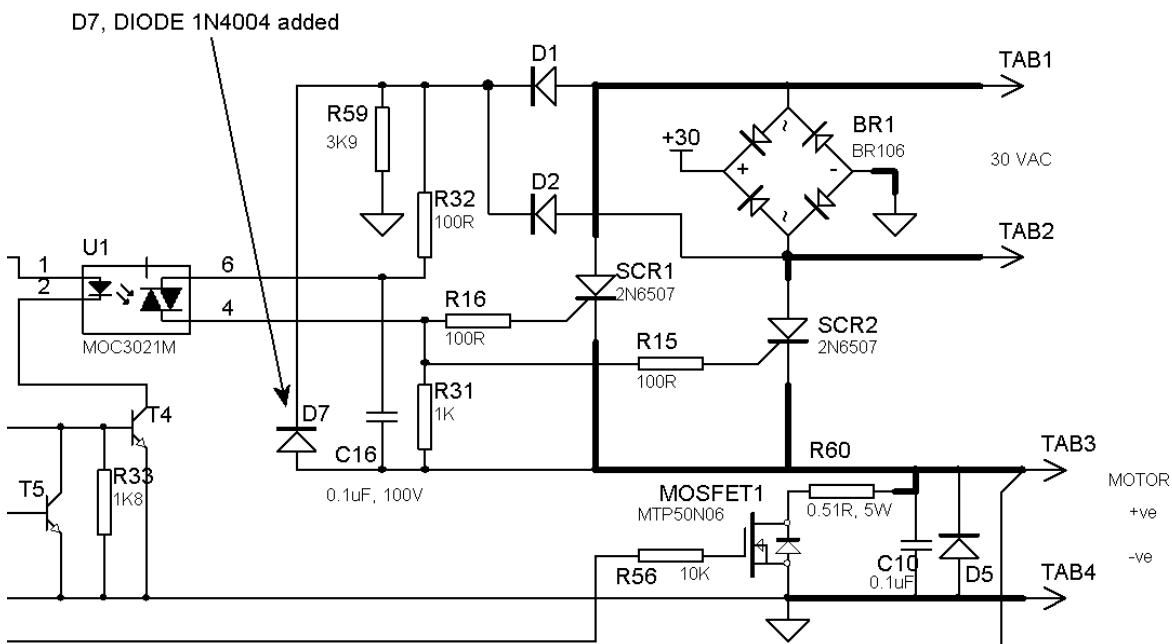
Fig 1, CP38-52 Circuit Showing Addition of D7

There have been some instances reported recently where the wire drive suffers from inconsistent speed. This problem has been traced to electrical noise which may be generated by the wire drive motor used on the W37 wirefeeder. This electrical noise can disrupt the speed control system of the CP38-52 wire/gas board, causing speed irregularity. The following circuit and instruction details a modification which prevents any noise of this type from causing speed irregularities.

A 1N4004 diode has been added to the CP38-52 pcb. Fig 1 shows the location of D7 in the CP38-52 circuit, and Fig 2 shows where D7 is located on the solder side of the pcb. A suitable alternative to the 1N4004 diode would be 1N4005, 1N4006 or 1N4007.

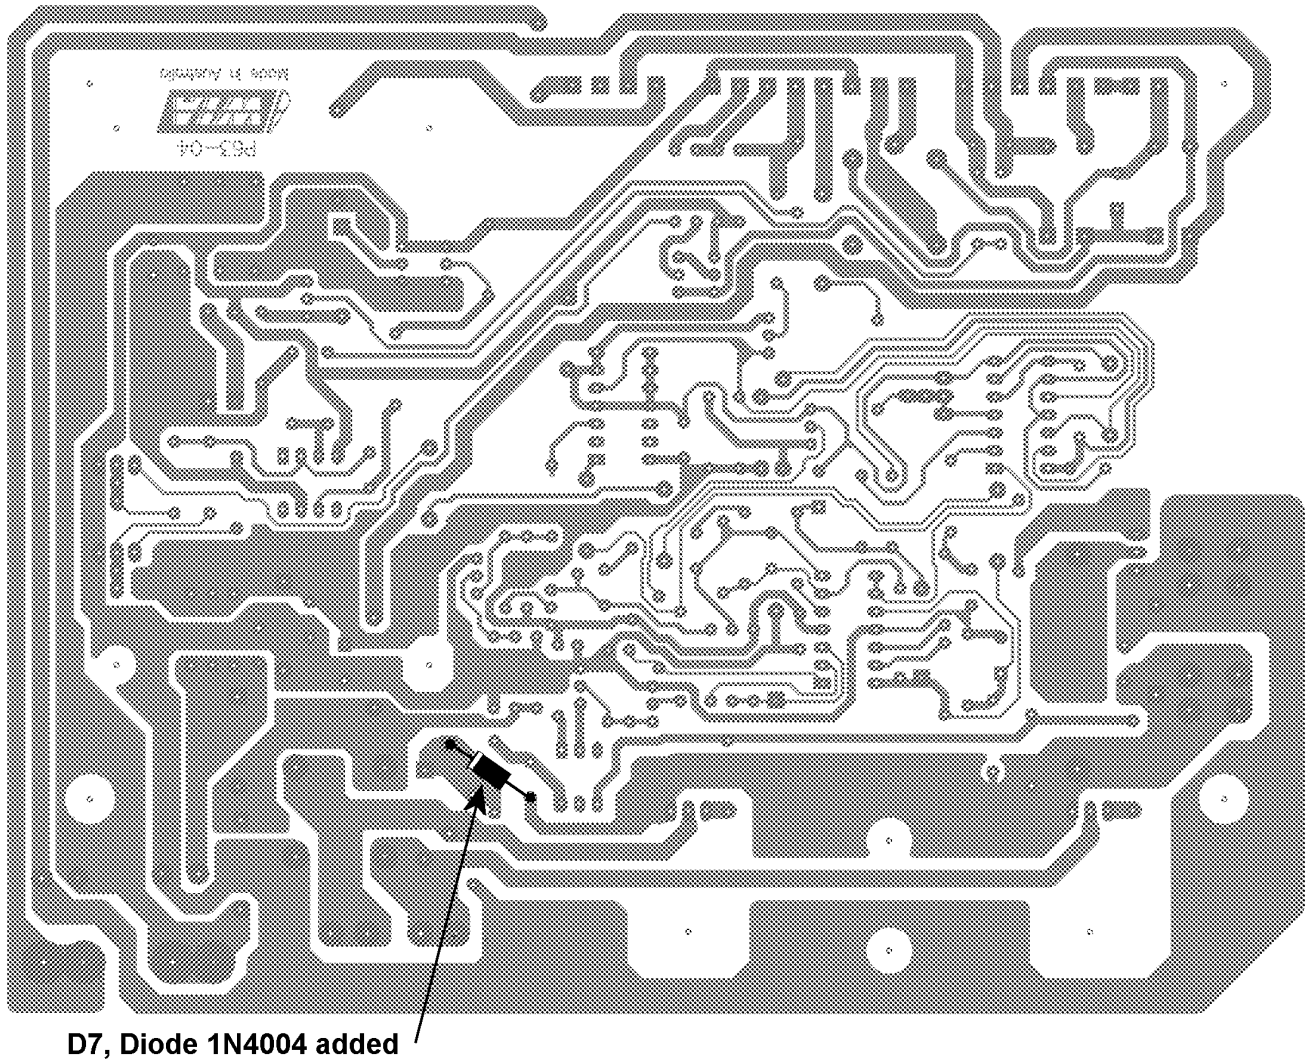
Fig 2, Location of D7 on Solder Side of PCB

D7, Diode 1N4004 added
