BULLETIN # 202B

MC91-0, 92-0 & 93-0, MC100-0,101-0 & 102-0

OUTPUT RECTIFIER REPLACEMENT

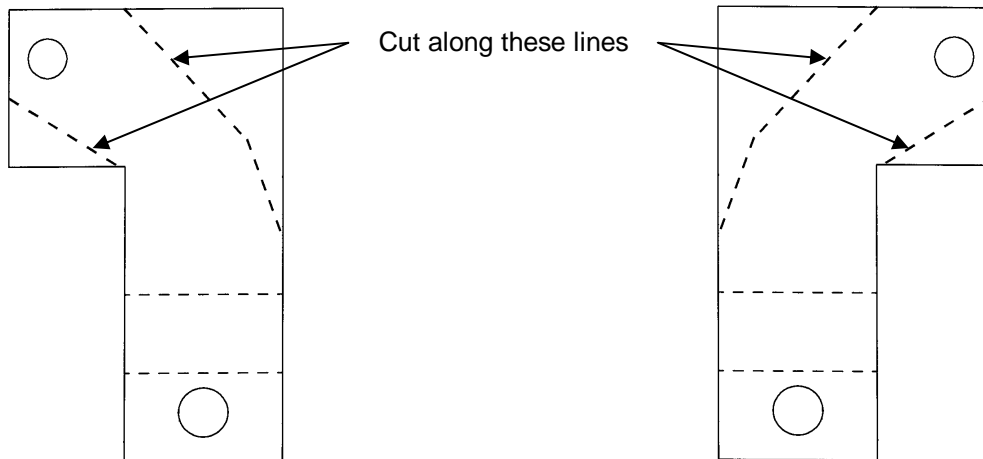
A new batch of output rectifier modules (part number D0017) have been causing the toroids on the output busbars to overheat during load bank testing. This is due to a change in the operating characteristic, and while the rectifiers still perform within their specification, this overheating problem now exists when we use them in our machines.

Use a sharp pair of snips or shears to modify the busbars which connect the transformer to the input terminals of the rectifier module to the following shape:

Order 2 more toroids, P/No L0006 and fit them on the modified busbars, making a total of 2 toroids per busbar.
