BULLETIN # 230B

MILLER PRO 300 CAT CC/CV

LOSS OF CV WELDING OUTPUT - DAMAGED INDUCTOR

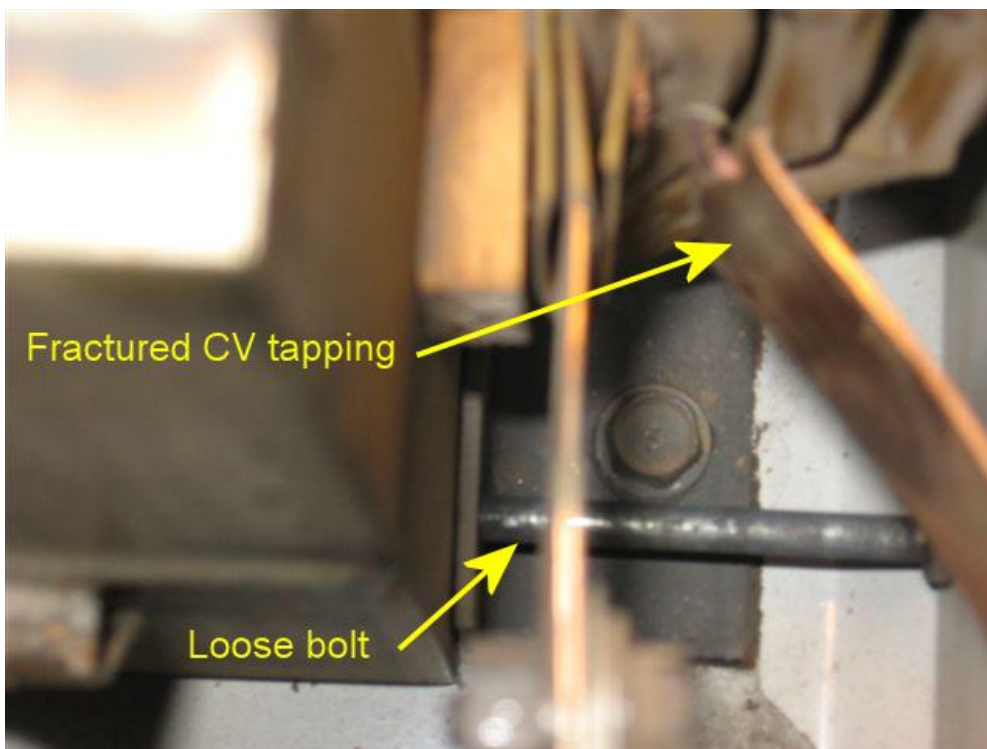
Loss of welding output in CV mode may be due to a damaged CV tapping on the inductor (stabilizer) of a Pro 300. This can be caused by excessive movement of the inductor which may occur if the bolts which extend through the mounting feet and the bottom of the inductor come loose.

If the CV tapping fractures it is likely that there will not be enough material extending from the inductor to allow for an effective repair, requiring inductor replacement. It is therefore essential that these bolts on a Pro300 are checked for tightness. See page 2 for a procedure for visually checking the nuts.

If they are not tight, the nut and washer must be tightened or replaced (1/4" Whitworth nut with captive washer) as required before the machine is used again to prevent damage to the inductor. Page 3 & 4 explain how to gain access to the front nut and bolt.
