BULLETIN # 232

AUTO-DARKENING HELMETS

ENERGIZER® BRAND BATTERIES IN MILLER AUTO-DARKENING WELDING HELMETS

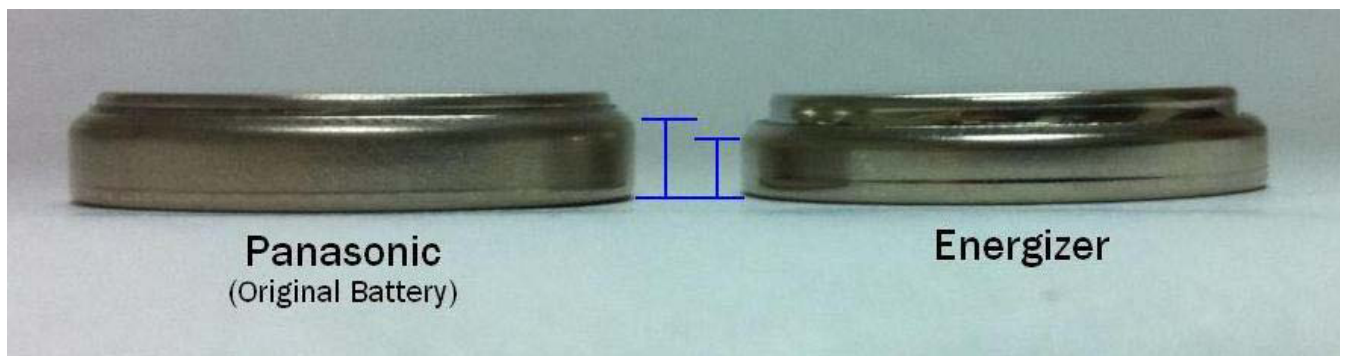
Battery Shoulder-Height Comparison

Energizer brand coin-cell batteries may cause some auto-darkening welding helmets to operate intermittently. Energizer batteries have a lower “shoulder” than other batteries which may cause a poor connection with battery tray contacts.

This issue affects auto-darkening welding helmets that use the CR2450 battery (Elite, Digital Elite, Performance, Xli and Xlix models).

If you have customers experiencing intermittent operation of their auto-darkening helmet lens, check the battery. Replace Energizer brand batteries with batteries (such as Panasonic) that have the required shoulder height.

Panasonic CR2450 batteries are available from WIA as part number 217043.
