Service Bulletin

BULLETIN # 254

MC105, WELDARC 200I AC/DC

CHECKING PRIMARY CABLE CLEARANCE

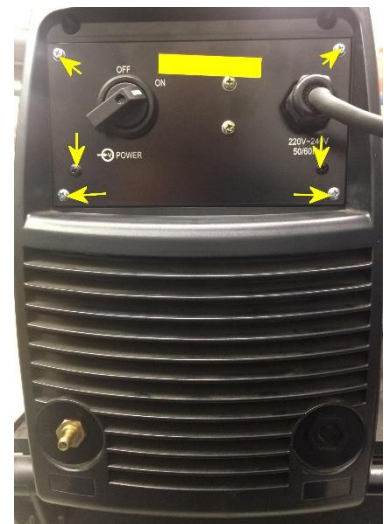
Remove 6 x screws from the cover plate on the rear panel as per photo. Normally removing this cover plate is sufficient to carry out the inspection, however it is expected that removal of the complete machine cover will be required if any remedial work is required.

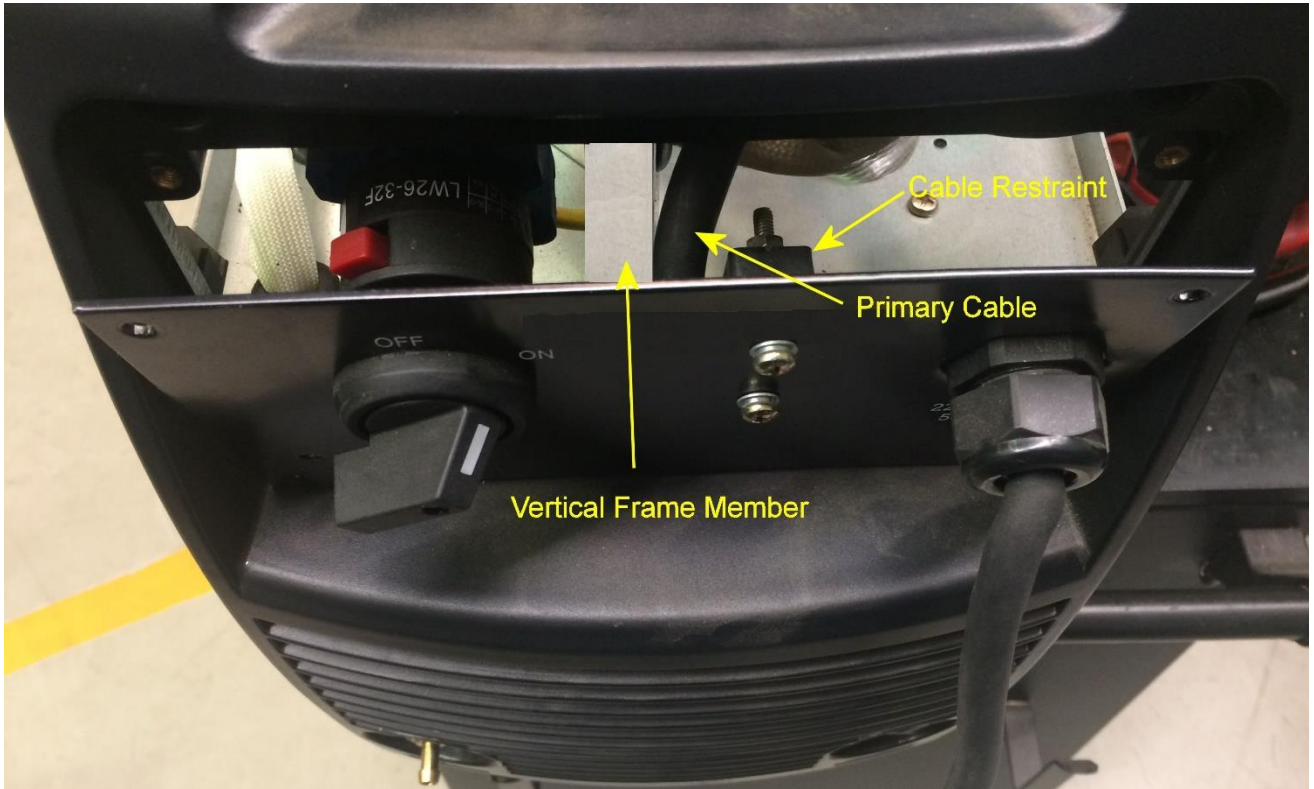
Inspection with Cover Plate Removed

There has been a small number of instances where the one wire of the primary cable has become squashed between the rear panel and the vertical metal frame member. This has resulted in the insulation being damaged and the wire has contacted the machine frame.

The outer insulation sheath of the primary cable must extend through the cable restraint such that the sheathing protects the primary wiring as it makes a sharp 90 degree bend to run along side the vertical frame member.

If the sheathed portion is correct as described above and does not require modification, then check that the active and neutral wires are only just long enough to reach the on/off switch without excess length. If either of these is too long there is a chance that it may become squashed between the rear panel and the vertical frame member. To rectify this either:

If it doesn't extend far enough, loosen the cable restraints and cable gland and extend a sufficient length of the sheathed portion through.

1. Shorten the 2 cables, and attach new forked lugs, or
2. Pull excess length towards the switch and restrain the cables with cable ties so that any excess length is prevented from coming back through the hole in the vertical frame member.
