# Service Bulletin

WSB261

## BIG BLUE 800 X DUO AIR PAK

### RED/BLUE COMPRESSOR OIL HOSES ROUTING

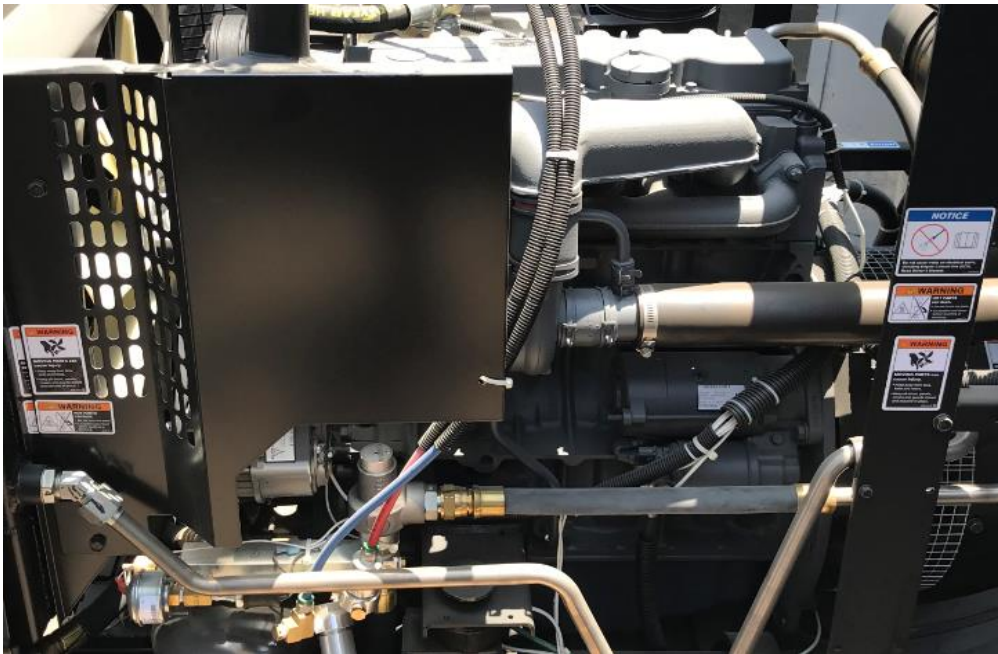
Figure 1

There have been several noted incidents of incorrect routing of compressor hoses (part numbers 218601, 218602)(Figure 1.).

Due to the incorrect routing, a combination of external heat and internal pressure has caused instances of rupturing hoses. Any hoses found to be routed inside of the heat shield are to be re-routed on the outside (Figure 2.). Any hoses found to have signs of heat related damage, without rupture, are to be replaced under warranty.
