Service Bulletin

BULLETIN # 272

WELDMATIC 250I

INPUT CABLE TOROID REPOSITIONING

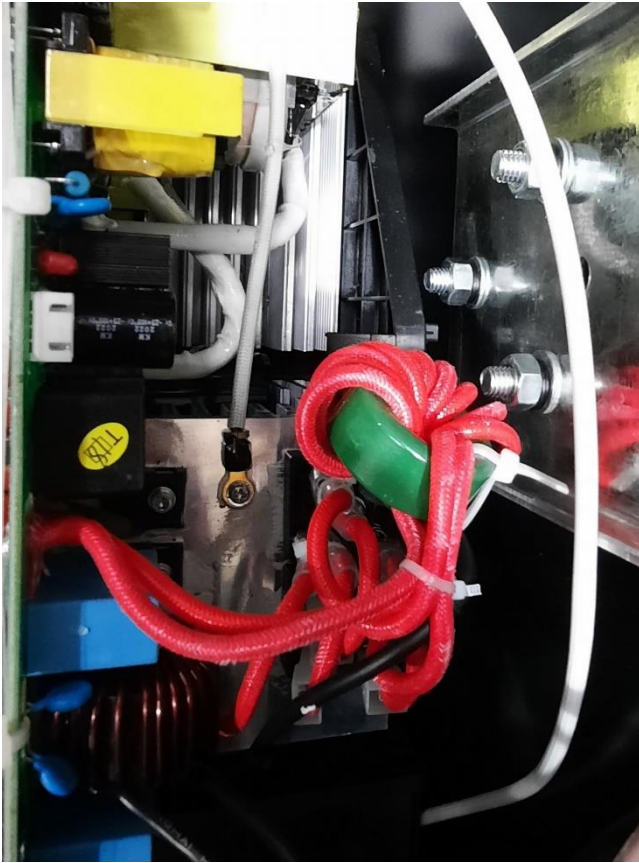
The input toroid shown in Figures 1 and 2 have been positioned incorrectly. The potential for the input cables on the toroid to chafe against the chassis of the machine is high and it should be repositioned.

Figure 1 shows the toroid mounted left/right – **this is incorrect.**

Figure 1 - Left/Right mounted INCORRECT

The input toroid is to be repositioned and secured to remove any potential chafing hazard.

Correct mounting can be seen in Figure 3 (page 3). Care should be taken not to reposition the toroid to cause further chafing on the heatsink below the new mounting position.

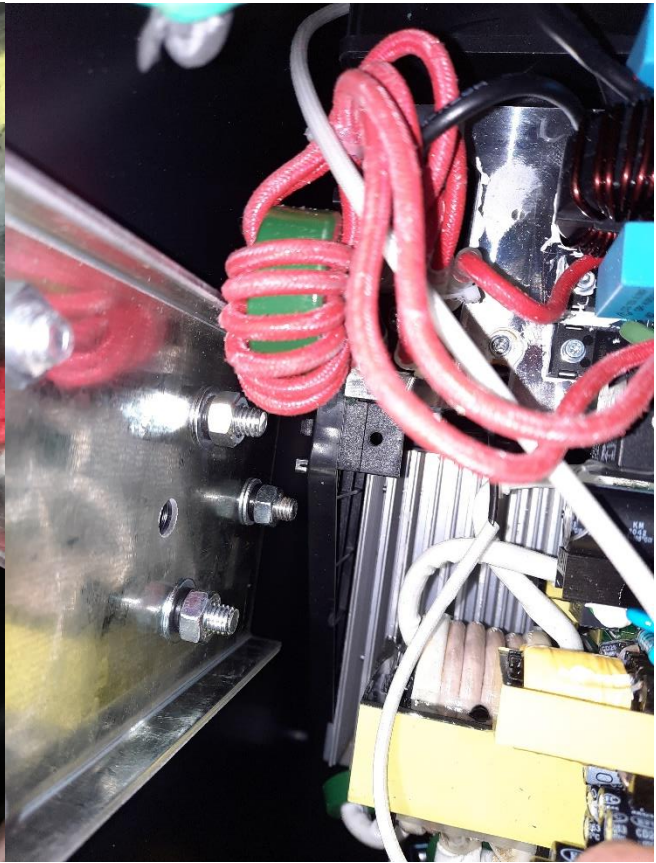
Figure 2 shows the toroid mounted forward/rear on the inside of the rectifier connectors – **this is incorrect.**

Figure 2 - Forward/Rear mounted INCORRECT

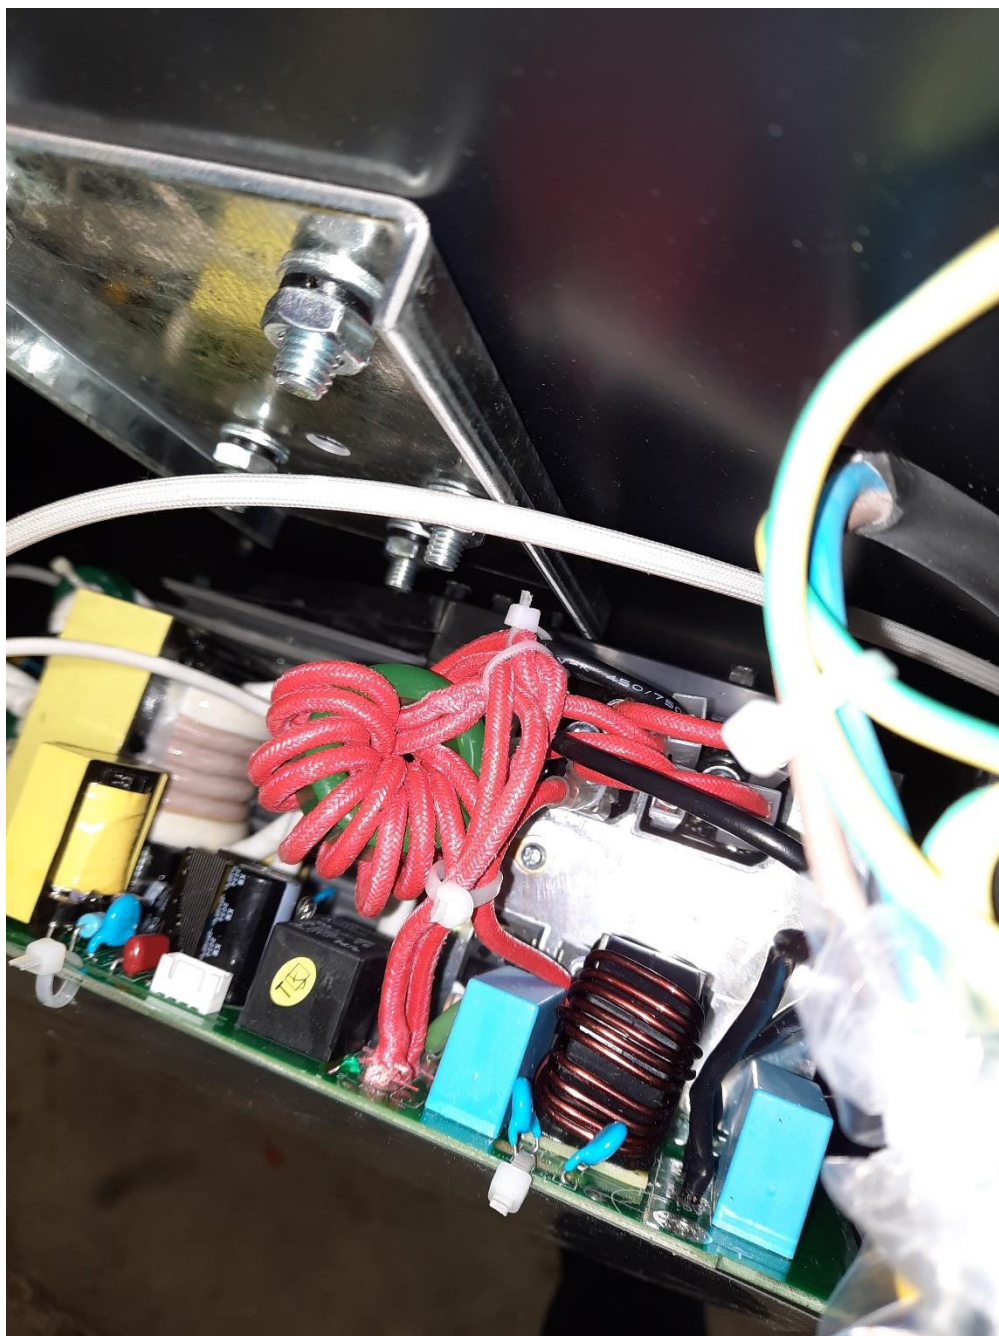
Figure 3 shows the toroid mounted forward/rear, in the **correct** position.

Figure 3 - Forward/Rear CORRECT
